Manhole Inspection Summary

Manhole # S27AA_022MH

Insp Date: **4/6/09 1:25 PM**

Location Address: **SHIELDS PL**

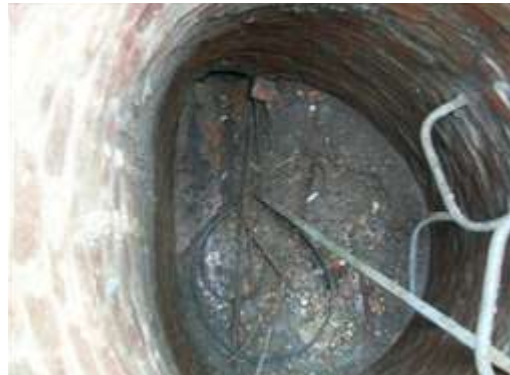
Top View

NOTE DEBRIS IN CHANNEL

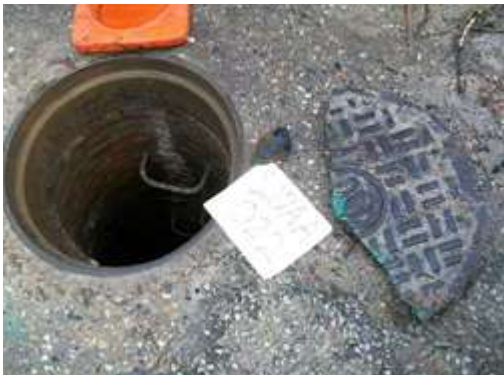
BROKE OPEN LID WITH HAND TOOLS

Comments **BROKE AND OPENED STUCK COVER. REPLACED WITH NEW 24" SANITARY LID BY REI/DRAYCO. INSPECTION COMPLETE.**

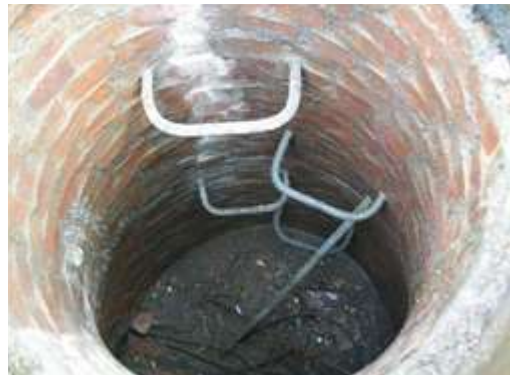
Defect 2

DEBRIS IN CHANNEL, STAINING ON CORBEL WALL INDICATES EVIDENCE OF INFILTRATION

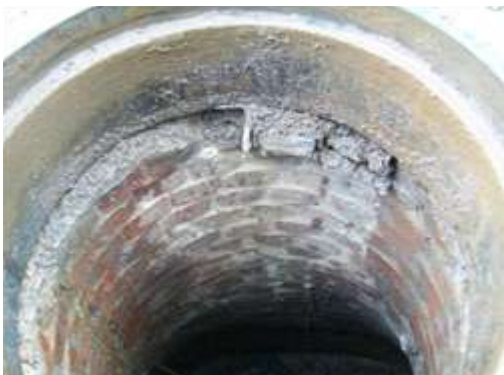
Defect 1

☒ **Leaks**

☒ **Loose Brick**

☒ **Deteriorated**

LOOSE AND MISSING BRICKS IN CHIMNEY - EVIDENCE OF INFILTRATION AT FRAME/CHIMNEY

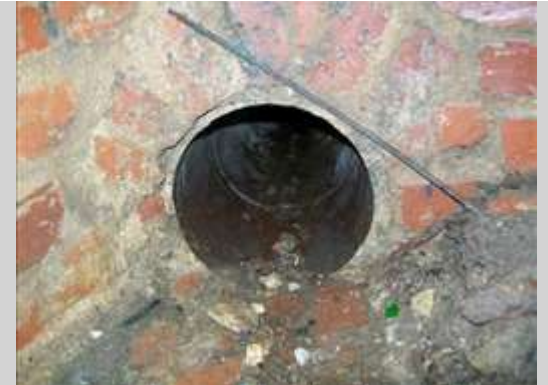
12 O'Clock Outflow

8 in. Circular Gravity Sewer
Pipe Out @ 12 O'Clock

Infiltration: **None** Pipe Seal Cond: **Sound**
